# East Coast Road – Slope Stabilization Project (ECR-SSP)

## Environmental and Social Impact Assessment (ESIA) Report

(Ver 4; updated 3<sup>rd</sup> December 2024)

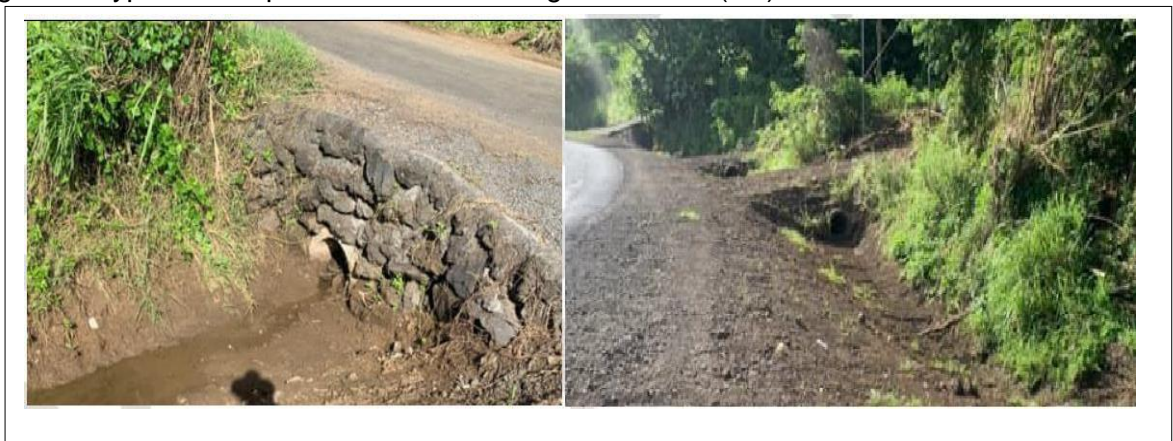
Figure 4: Typical examples of culvert crossing under road (left) and roadside swale drain

Stormwater drainage at the targeted landslip risk sections of the road will be improved / upgraded to avoid flooding at these locations and to improve stability. In some locations, new drains will be formed to improved stormwater management. Similarly, new (and/or increased capacity) culverts to convey water under the road to discharge into the sea will be constructed.

Existing roadside stormwater swale drains will be upgraded and new cross culverts under roads will be installed.

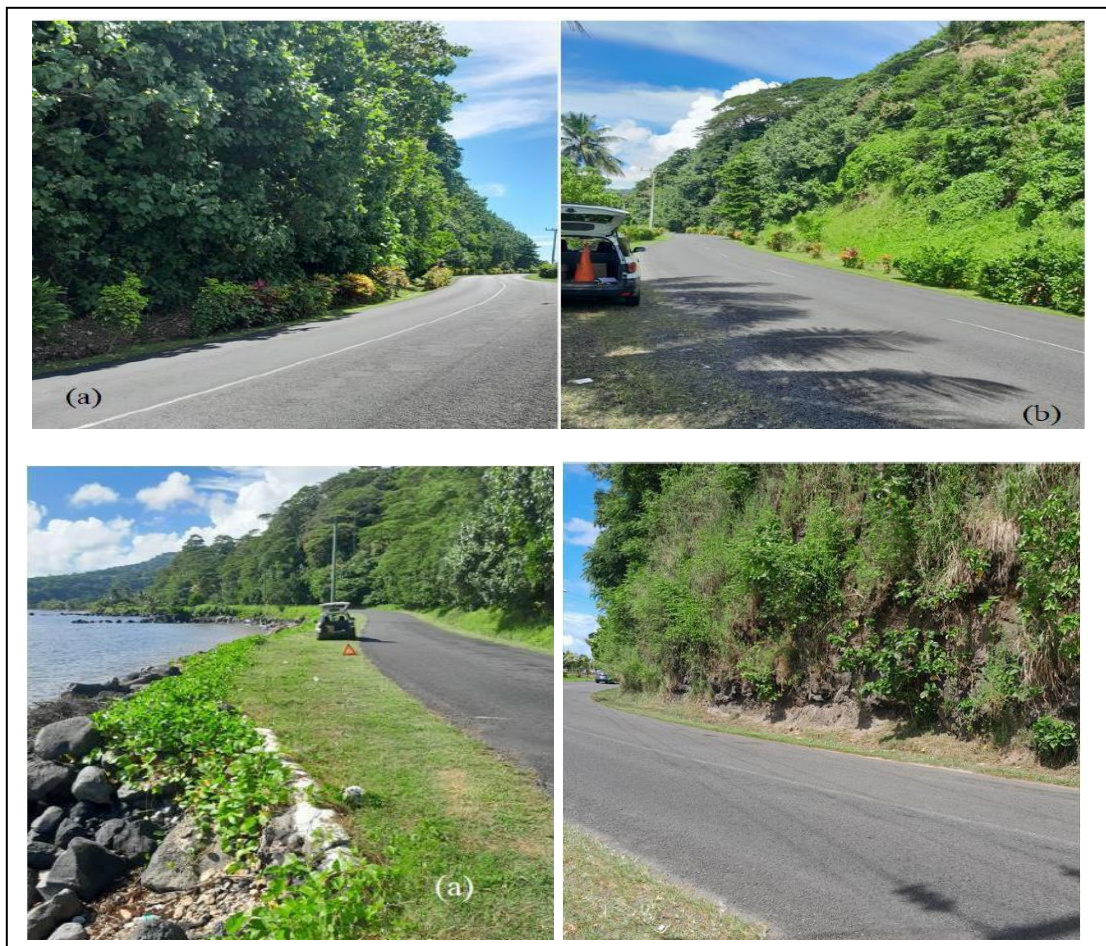
Figure 5: Views of the ECR showing steep rising slopes on the landward side.

Heavy and prolonged rainfall events pose the main climate risk to the stability of slopes along the ECR. Fepuleai et al (2023) noted that several factors trigger instability of rocks/soils in the ECR, one of which is exposure to ‘climate variations’ (alternative hot and wet conditions). Unloading of overburden is also known to be facilitated by wet soil conditions. Available information noted that Eastern Upolu including the ECR districts of Vaimauga East and Anoama’a generally receives more rainfall than the north central and western side of Upolu with extreme rainfall events occurring during the wet/cyclone season from November to March.

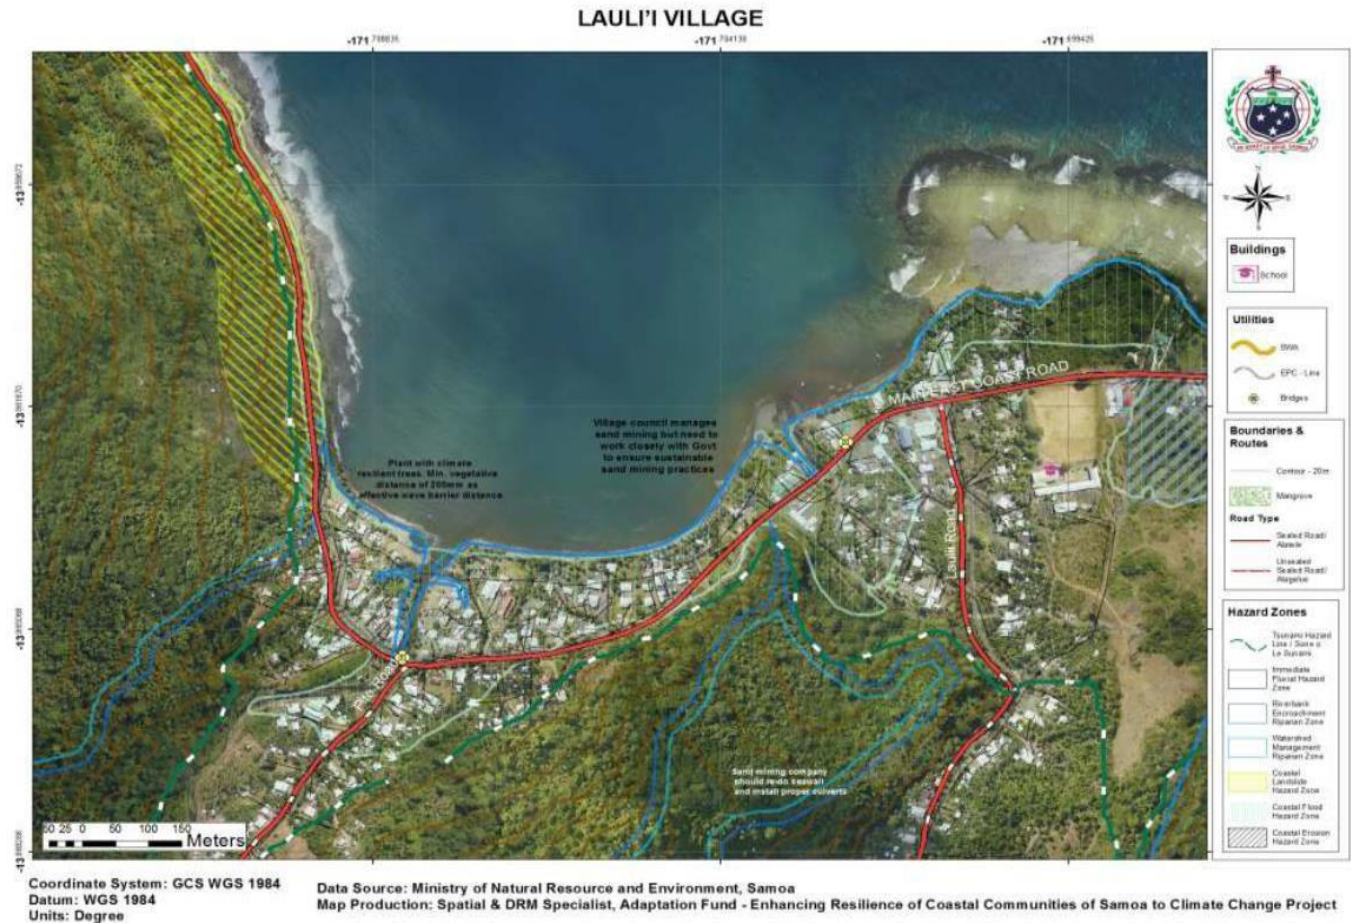
Figure 8: CIM Plan for part of Letogo and Laulii coastal areas showing different hazard zones (Source: MNRE, CIM Plan, 2018).

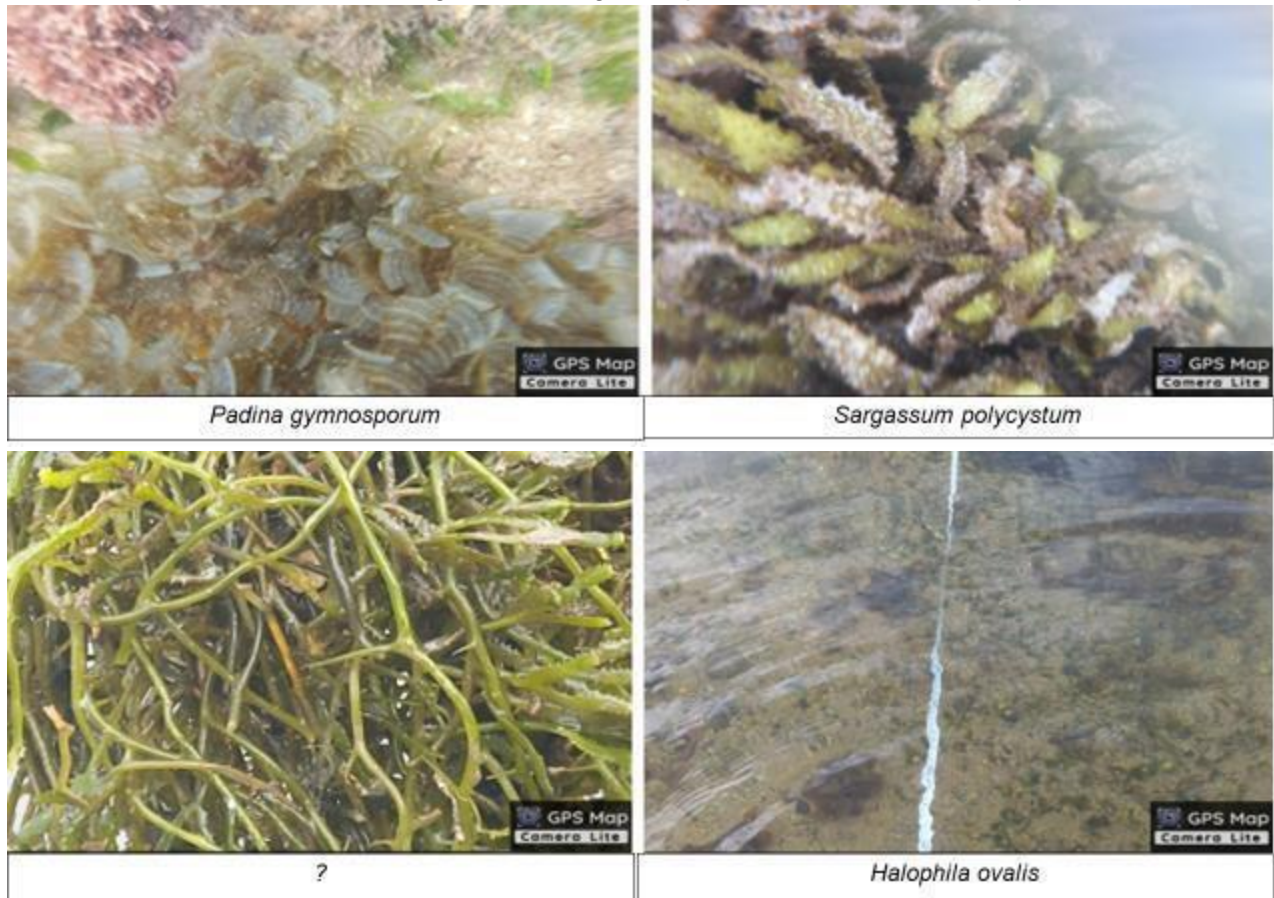
Plate B: Marine algae and seagrass species recorded in the project coastal area

Marine algae makes up 33% cover and is the most dominant biodiversity indicator along the coastal area surveyed. Algae prefer certain environmental conditions for good growth however, they occur in abundance as the surveyed areas are directly exposed to excessive sediment and nutrient run-off from the land as well as high temperatures during low tide – these are favourable ingredients for algal growth. The most abundant species recorded include the brown algae *Sargassum polycystum* (Limu faaleagamea), brown algae *Padina gymnosporum* (Limu lautaliga) and paddle weed seagrass *Halophila ovalis*. These species are commonly found in disturbed tidal flat and reef areas with high nutrient supply.

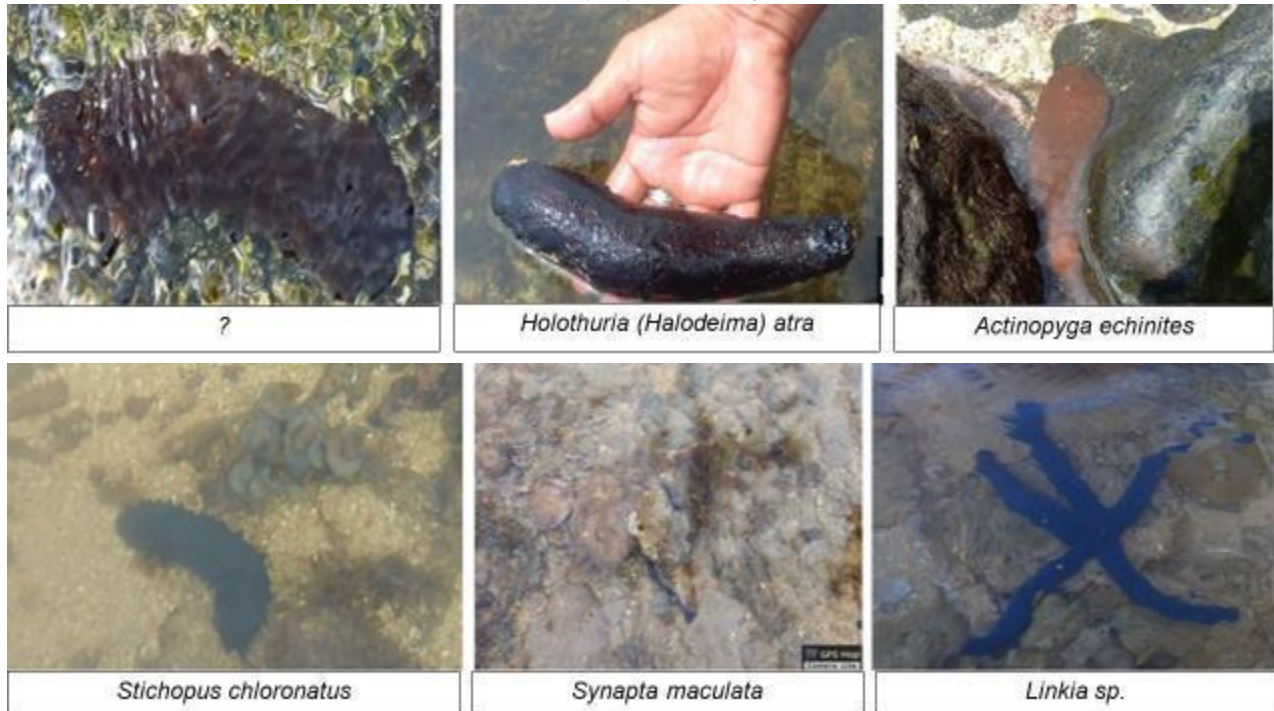
Plate C: Invertebrate species recorded in the project survey area

The outer lagoon and reef provide nursery areas for a variety of fish and invertebrate species because of the many biological niches and habitats available. The surrounding areas are generally alive and a spill-over corridor for mobile species to forage especially during high tide. However, the intertidal and beach areas surveyed are highly disturbed (habitats and noise) and lack habitats to support fish foraging or residency. Sandy and coarse substrate conditions are favorable for sea cucumber species recorded. These are deposit feeder organisms that extract food particles from the water column or the sediment or the substrate by using their tube feet.

The low occurrence of biotic features and the low diversity of corals and invertebrates in the area is indicative of severely degraded habitats. There were no notable signs during the survey of recent runoff events along the coastline that would point to a direct recipient/source relation with the ECR or other land based activities. However, drainage outfalls (several of which are visible from the survey area) do discharge silt, debris and surface water run-off into the beach and intertidal zones. Overall, the survey shows a pre-project receiving environment that is already severely degraded. In so saying, marine biodiversity in the surveyed area is likely to be much lower than the wider marine area.

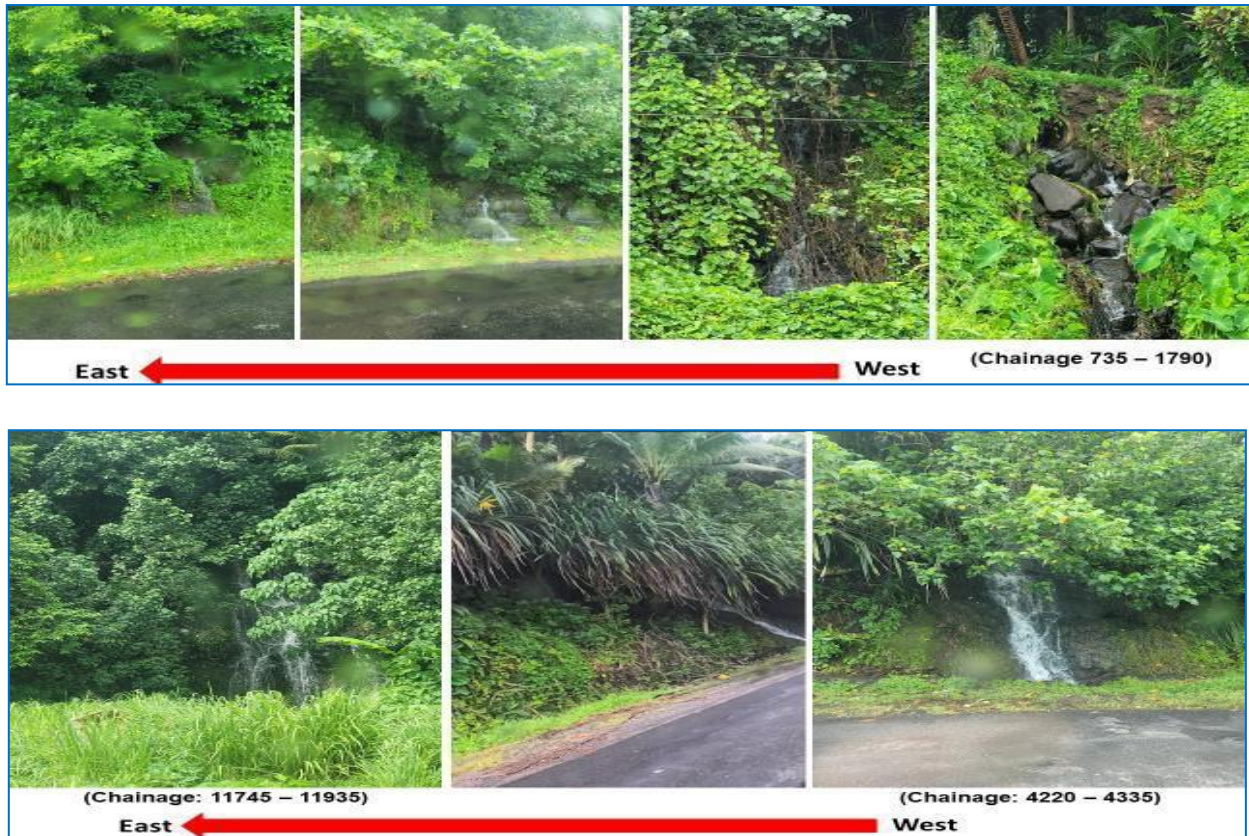
Figure 10: Intermittent surface stormwater flows off the slopes in the ECR targeted sections zones.

Table 2: Location of intermittent surface flows observed

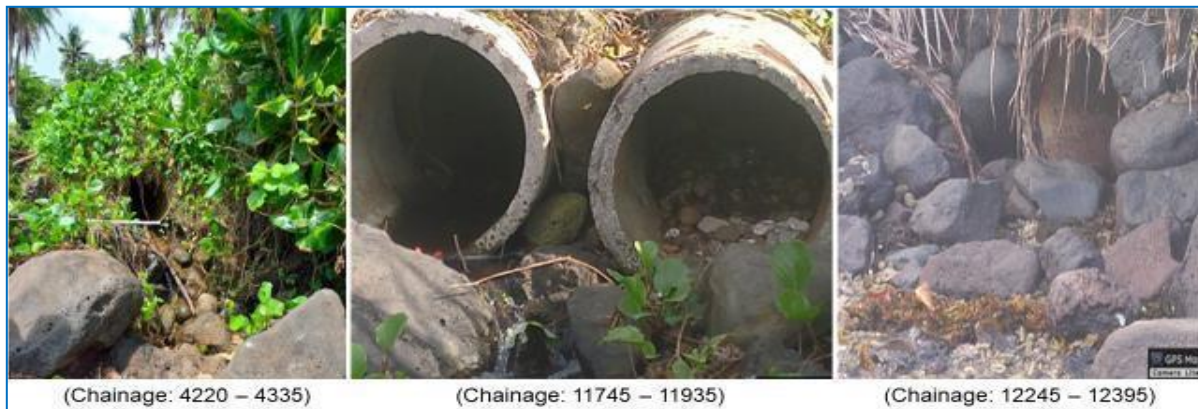
Figure 11: Piped outfalls discharging surface water runoff into the sea between Letogo and Lauili.

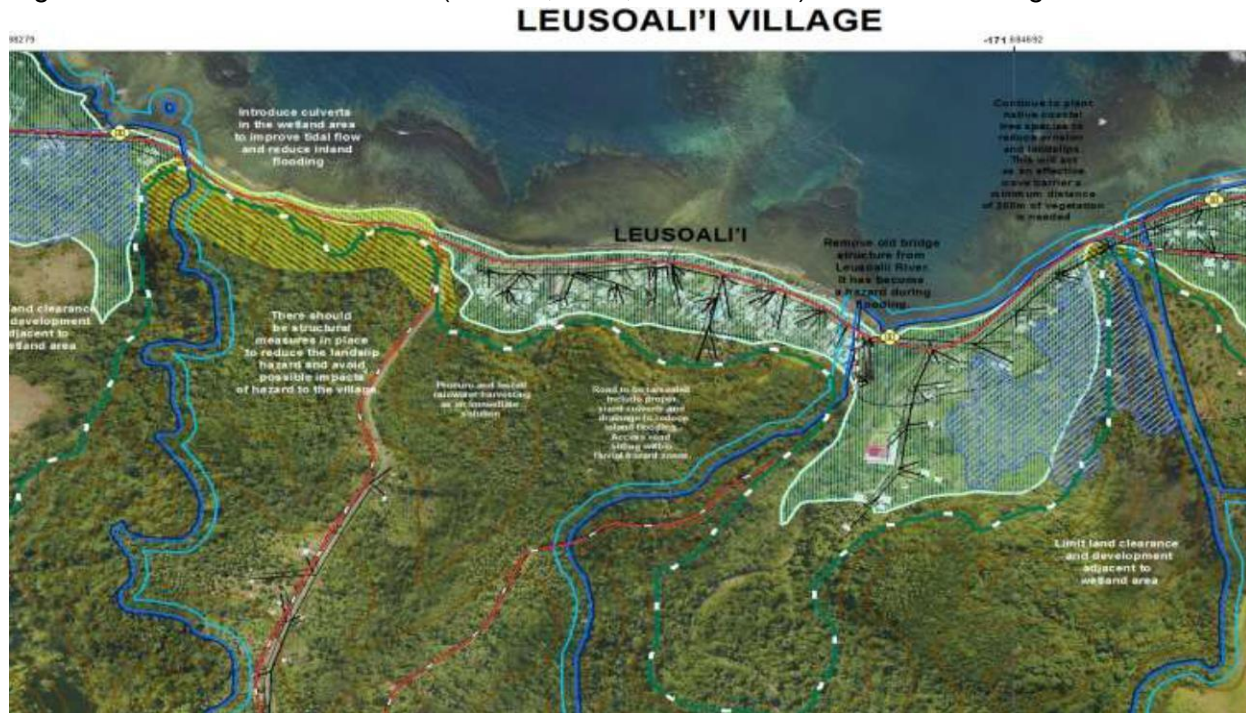
Figure 12 : Coastal hazard zones (erosion, flood, and tsunami) in Leusoali'i Village

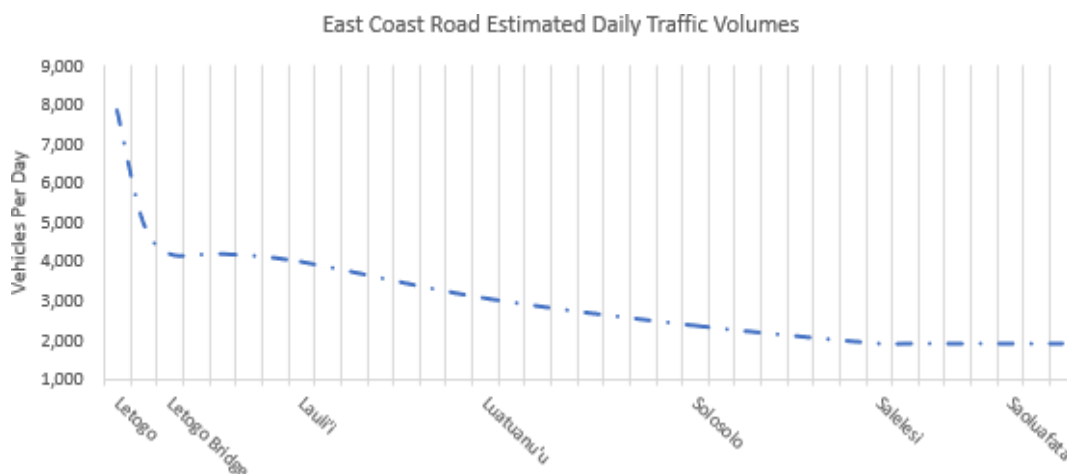
Figure 20: ECR Estimated Daily Traffic Volumes

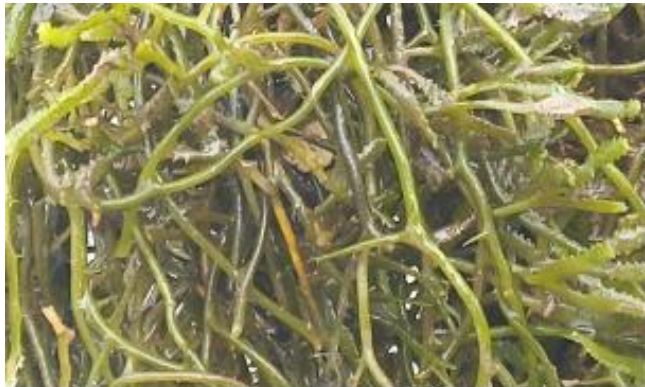
**Figure 3: Marine biodiversity of Site 1**

Marine algae (*Sargassum sp.*) and Seagrass (*Halophila ovalis*) cover about 90% of the area surveyed as they are favorably established in the muddy substrate. An estimated 5% live encrusting corals were noted between 20m and 30m distance from the coastline where the substrate becomes slightly sandy and partly exposed at low tide. Some rocks / stones were also noted being well grounded in the mud.

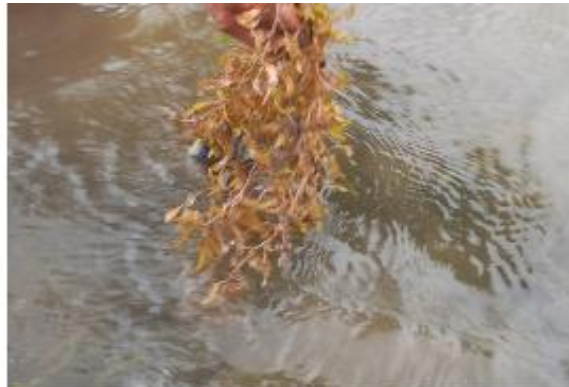
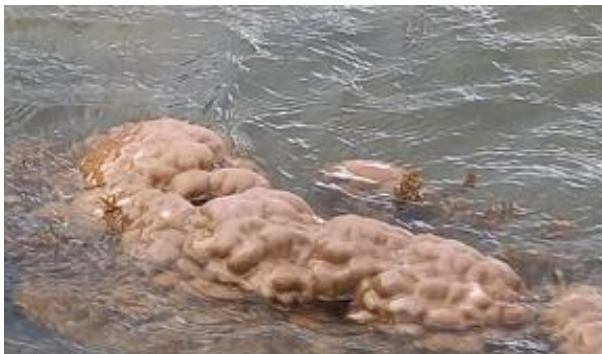
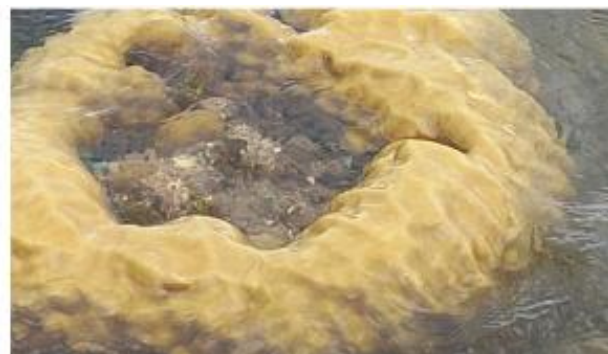
*Sargassum sp.*

Encrusting coral boulders

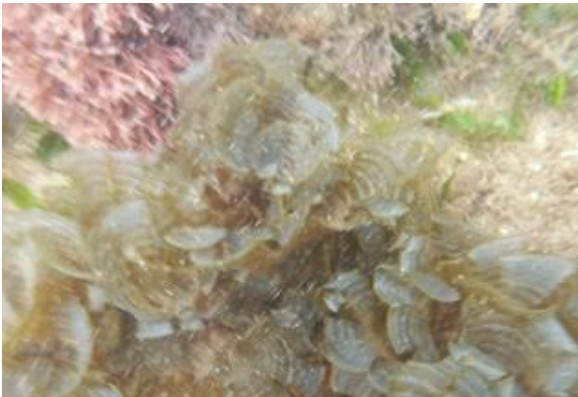
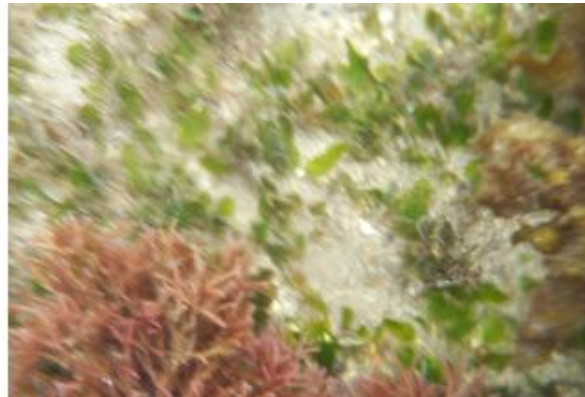
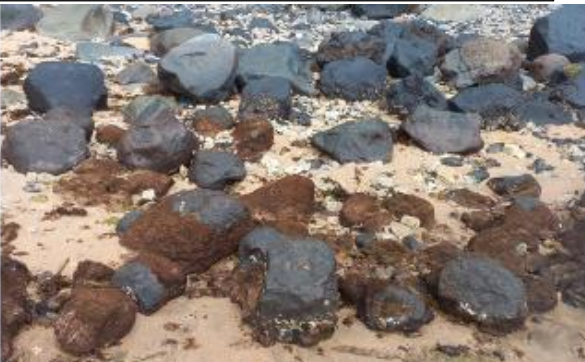
**Figure 4: Marine biodiversity of Site 10**

This site is about 85% sandy with very good water clarity. Marine algae species *Sargassum* and *Padina* are highly abundant (90%) and well established on sandy bottom. No invertebrates, fish or live corals were recorded in the survey area. Few medium-size rocks and stones occur in the vicinity of the coastline.

*Padina pavonica*

*Sargassum sp. & Halophila ovalis*

Rocks / stones near coastline

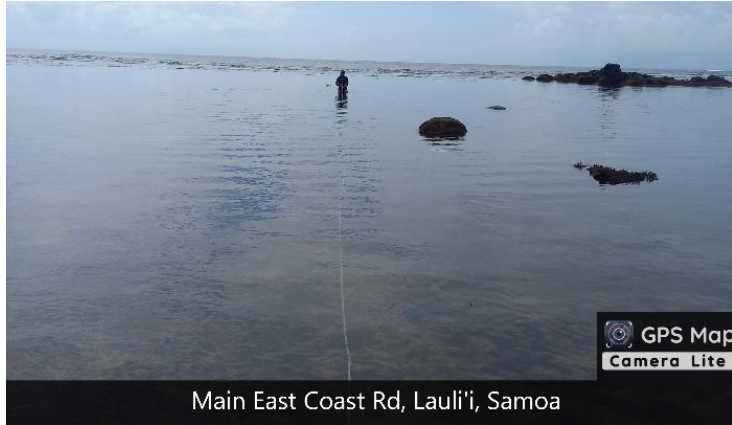
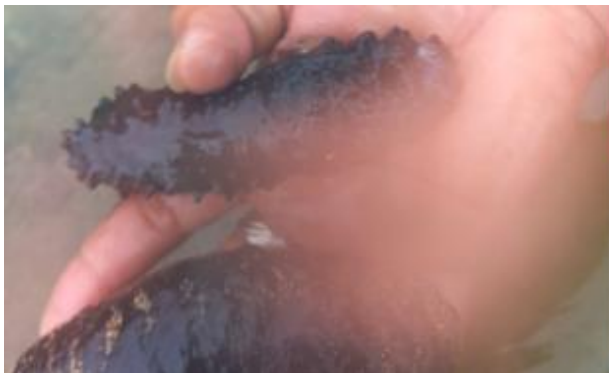
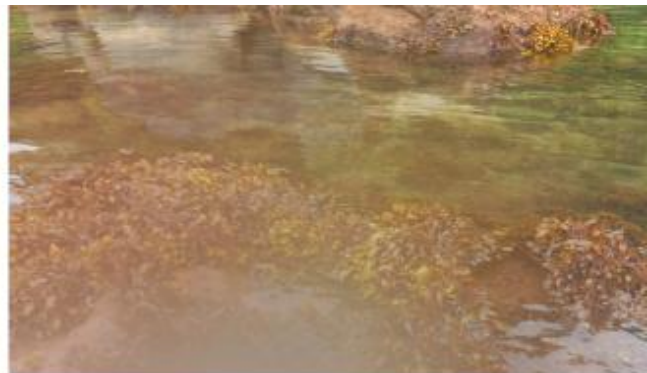
**Figure 5: Marine biodiversity of Site 11**

There were no fish or live coral recorded in this site but only a number of holothurians / sea cucumbers namely the Loll fish (*Holothuria (Halodeima) atra*) and Greenish (*Stichopus chloronatus*).

Sand is the dominant substrate (70%) although silt was also noted. This is slightly a high energy area and some coral rubbles were also noted amongst the rock boulders. Marine algae i.e. *Sargassum sp.* is highly abundant. There are some weathered rocks favorable for algal growth in addition to dead coral hosts (DCA).

*Stichopus chloronatus*) and *Holothuria atra*

*Sargassum sp.*

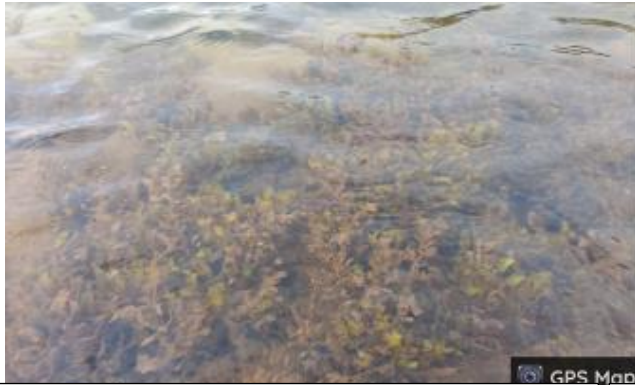
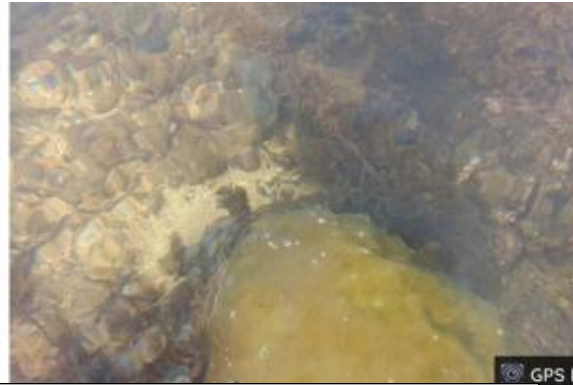
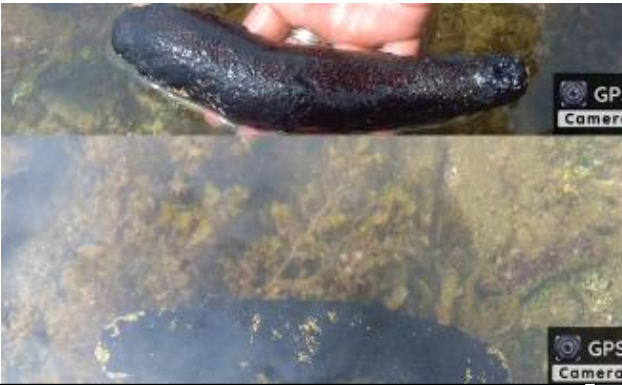
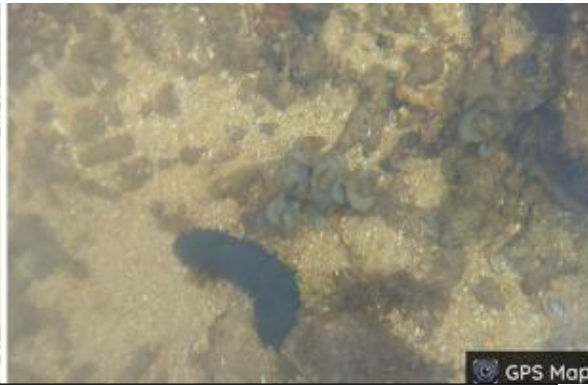
**Figure 6: Marine biodiversity of Site 12**

*Sargassum sp.*

*Padina pavonica*

*Holothuria (Halodeima) atra*

*Stichopus chloronatus*

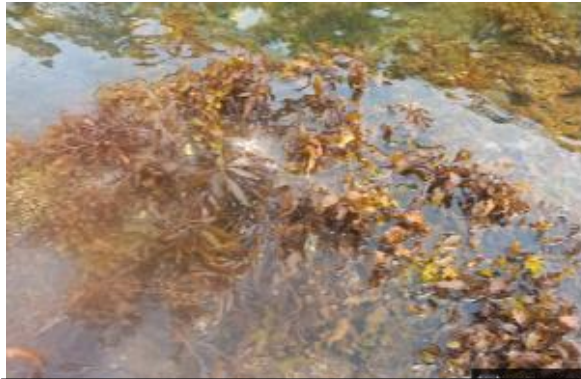
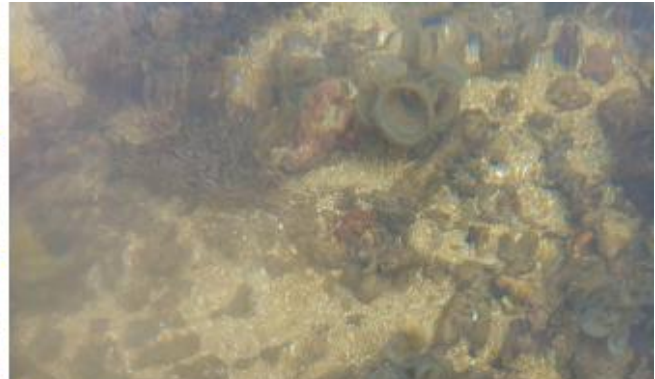
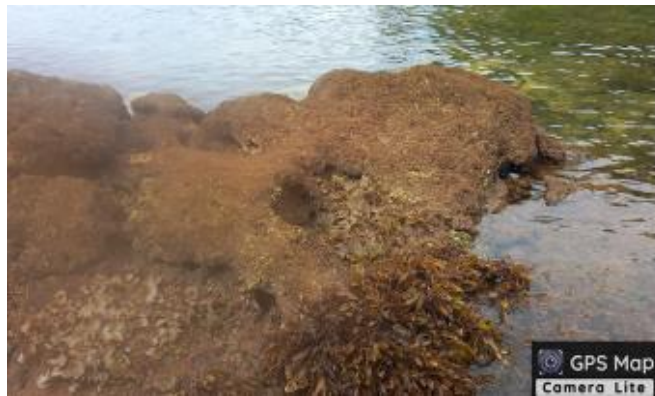
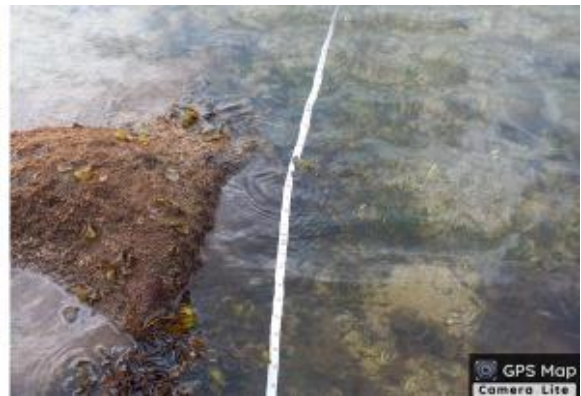
**Figure 7: Marine biodiversity of Site 13**

*Sargassum sp.*

*Padina pavonica*

*Sargassum sp.* well established on weathered rocks and dead corals

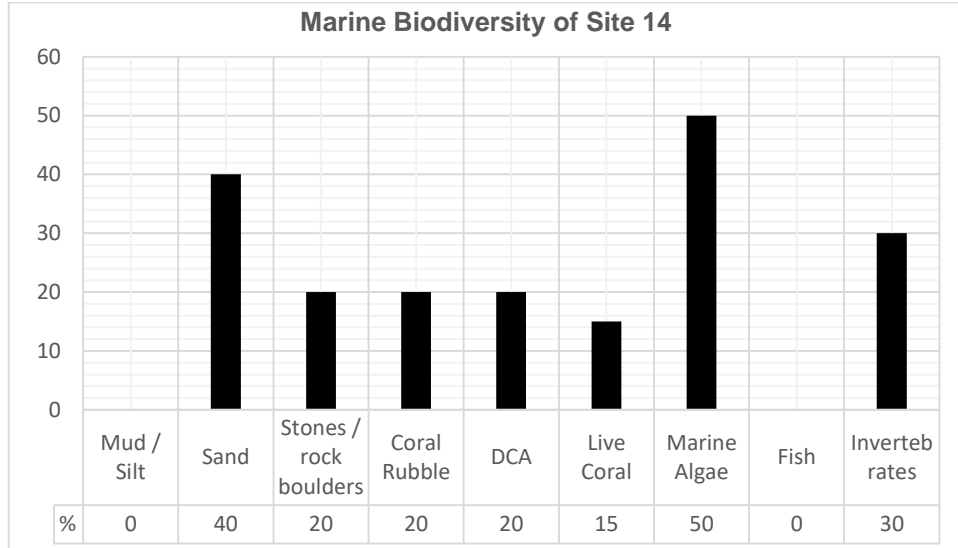
**Figure 8: Marine biodiversity of Site 14**

This site is a high energy area with the barrier reef about 300 meters further out from the coastline. Winds from the east blow currents towards the west. Water clarity is about 90% and there are no traces of siltation or runoff along the beach or coastline.

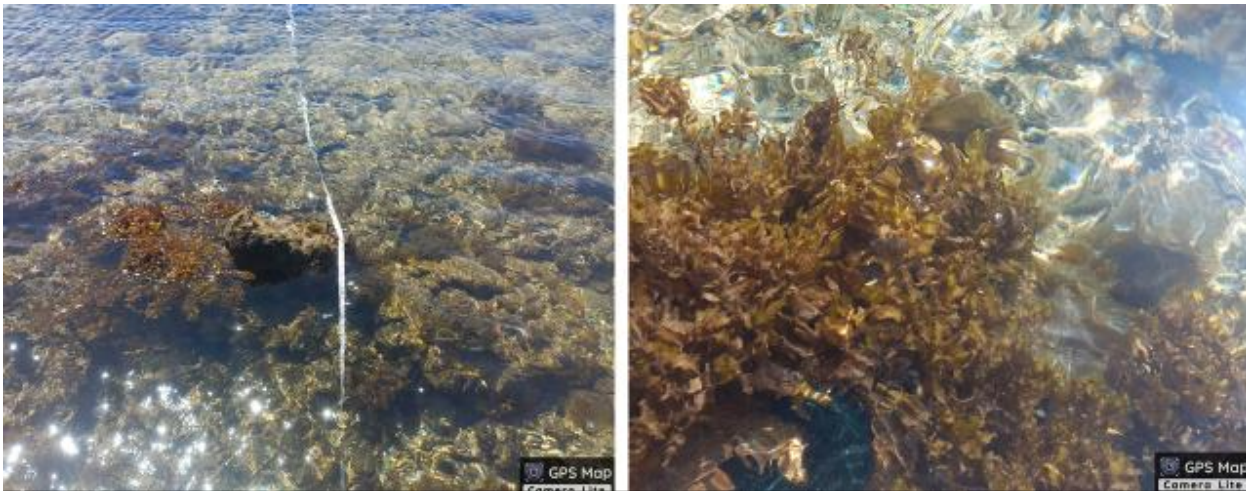
The *Sargassum* marine algae is highly abundant and well established in this area, noted to be overgrowing dead corals and weathered rocks. Live table corals and massive corals exist here with several sea cucumbers (Green fish and Lolly fish). Sand is the dominant substrate (40%) with many small stones among the rubbles and a rocky protrusion. The rubbles are indicative of a high energy area and have mostly been brought to shore by strong wave actions.

*Sargassum sp.* well established and overgrowing dead corals and weathered rocks

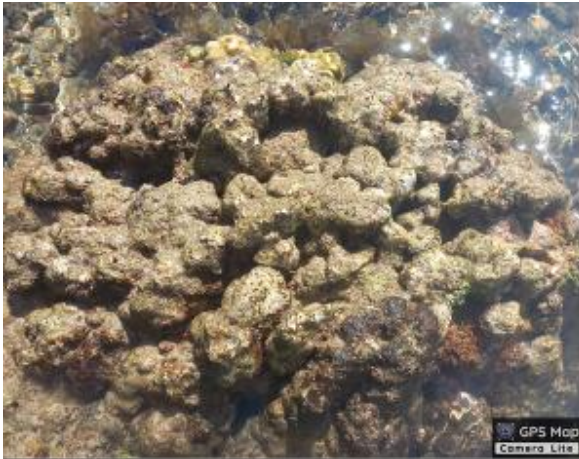
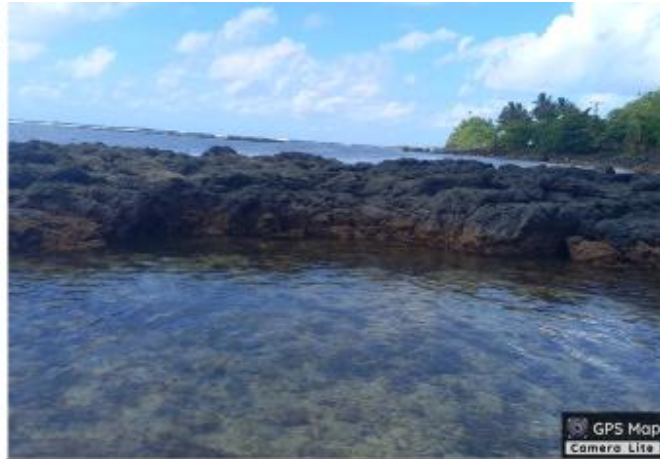
Massive coral

Rocky protrusion

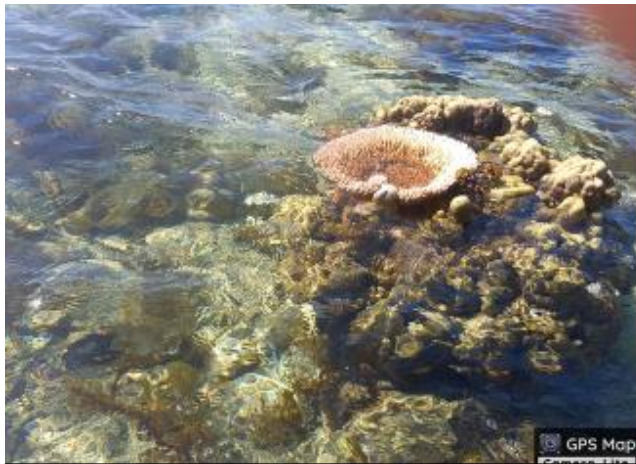
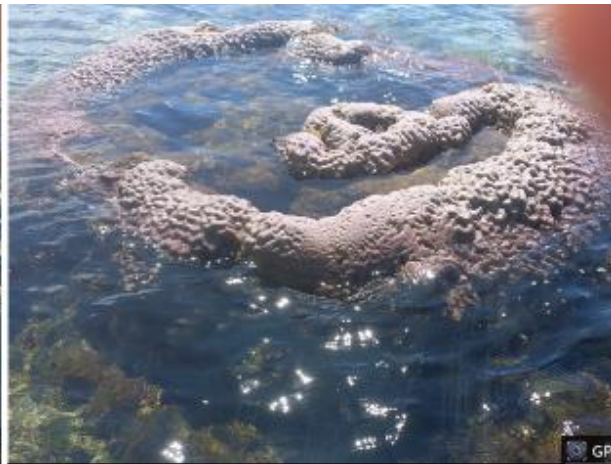
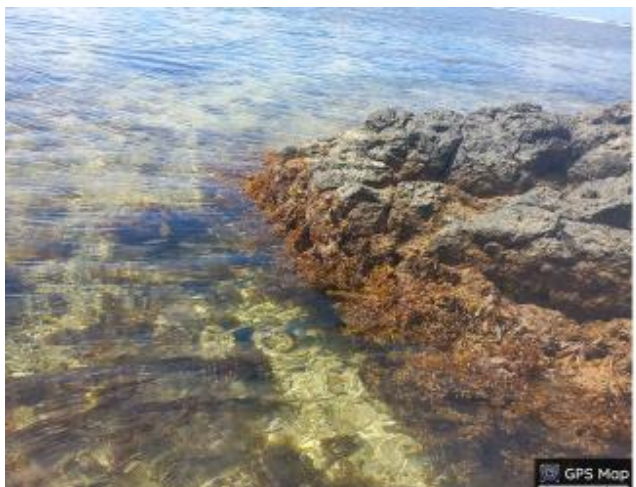
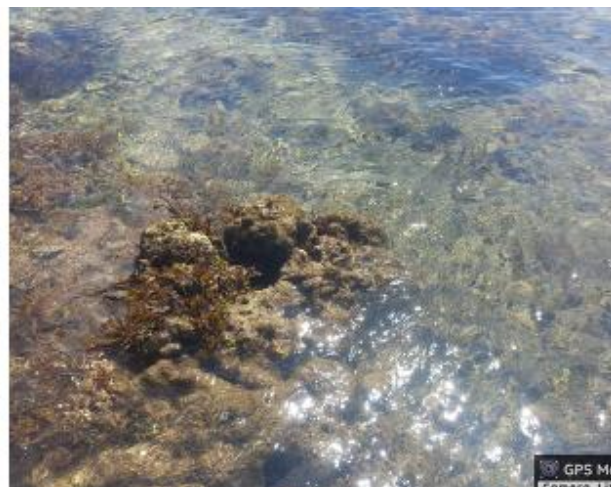
**Figure 9: Marine biodiversity of Site 15**

This site is a high energy area similar to Site 14. The substrate is dominantly sand (40%) with several scattered stones and rock boulders and coral rubbles (20%). Some dead corals overgrown with algae (20%) were noted. Live coral cover is about 15% and mainly of the table form (*Acropora sp.*) which are commonly found in high energy areas. Brown macro algae (seaweed) of the types *Padina pavonica* and *Sargassum sp.* are very abundant with an estimated cover of 70%. Sea cucumbers both green fish and lolly fish are more abundant in this area.

*Acropora sp.*

*Encrusting coral*

*Sargassum sp.* on weathered rocks

*Sargassum sp.* on dead corals

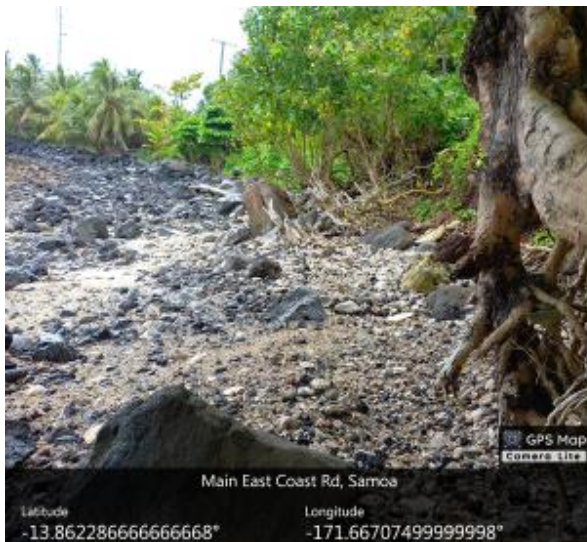
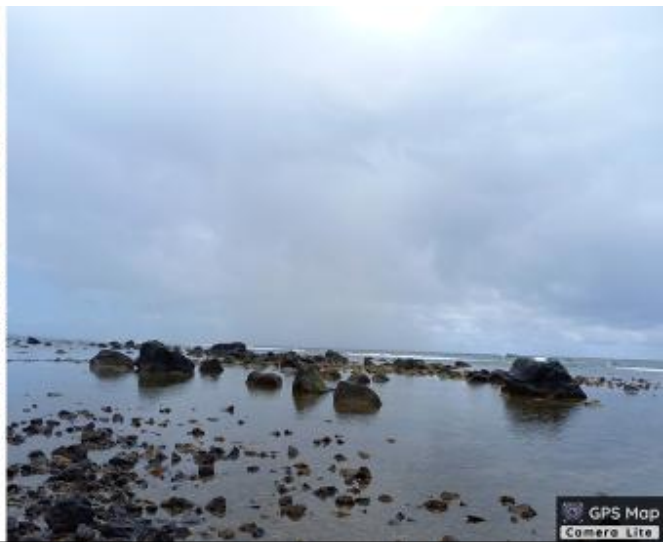
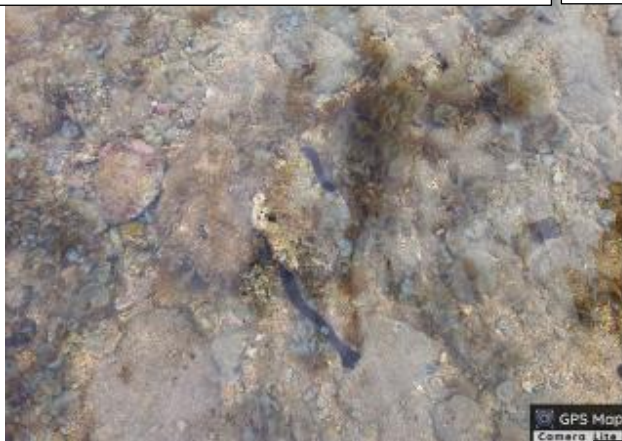
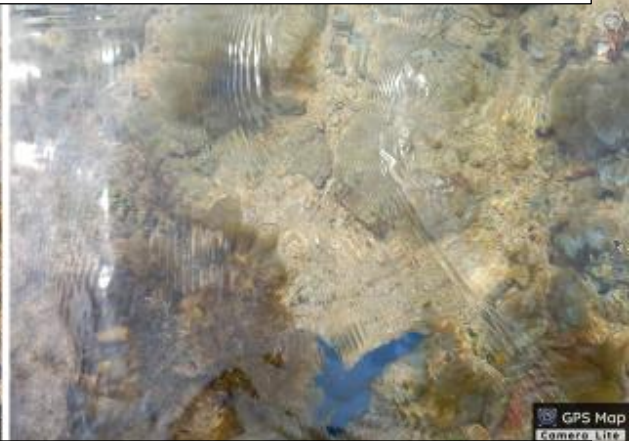
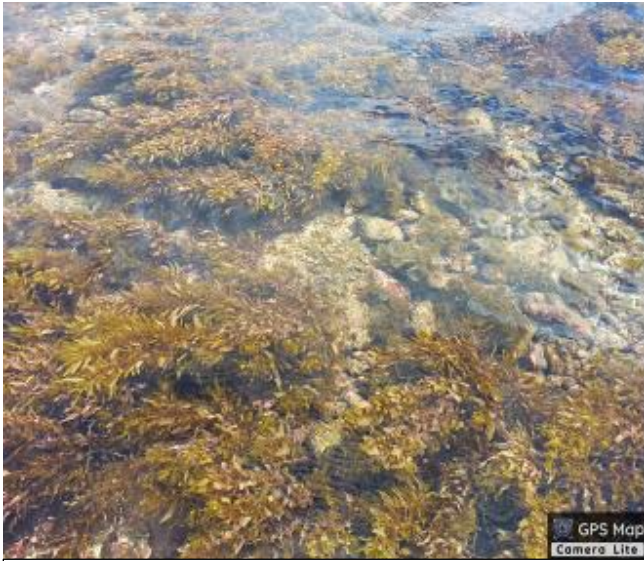
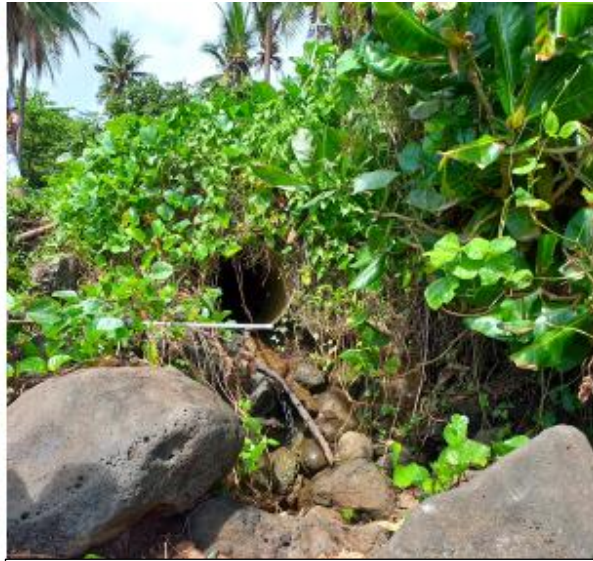
**Figure 12: Marine biodiversity of Site 18**

This is a very high energy site as the reef is about 30 meters further out from the coastline. Coastline erosion was noted as indicative of trees with exposed roots and a silty beach dominated by algae. Also noted is the road drainage culvert that discharges surface water into the sea.

Marine algae (*Padina* & *Sargassum*) cover about 50%. Invertebrates recorded include juvenile green fish and blue starfish. Coral rubble cover is about 30% occurring mostly within 10 meters from shoreline. Sand and silt are equal dominant with scattered stones. There were no live coral or fish noted.

Exposed roots with a thick layer of coral rubble

Scattered stones

*Synapta maculate* (Peva)

Blue Starfish (*Linkia sp.*)

*Sargassum* sp on coral rubbles and stones

Road drainage culvert

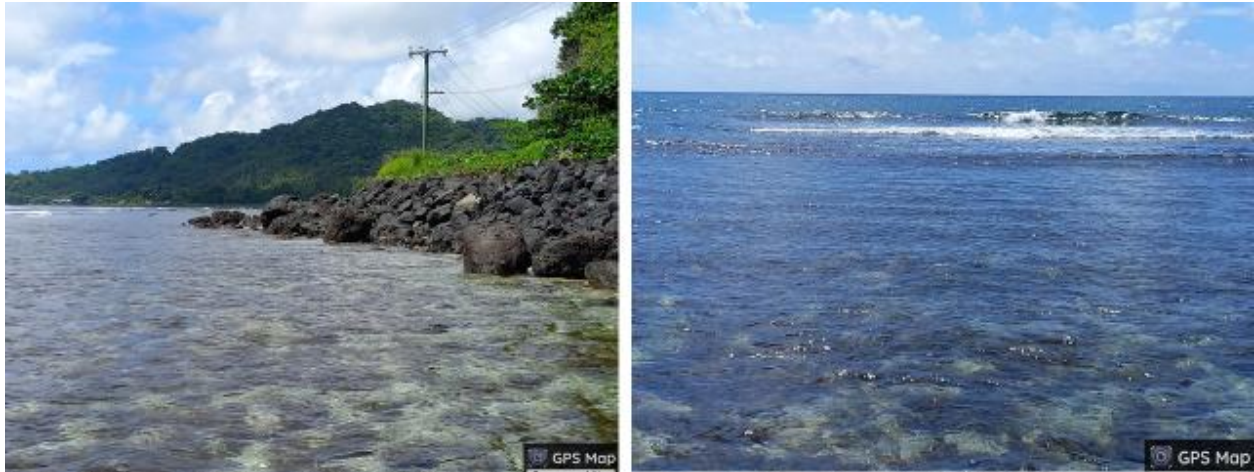
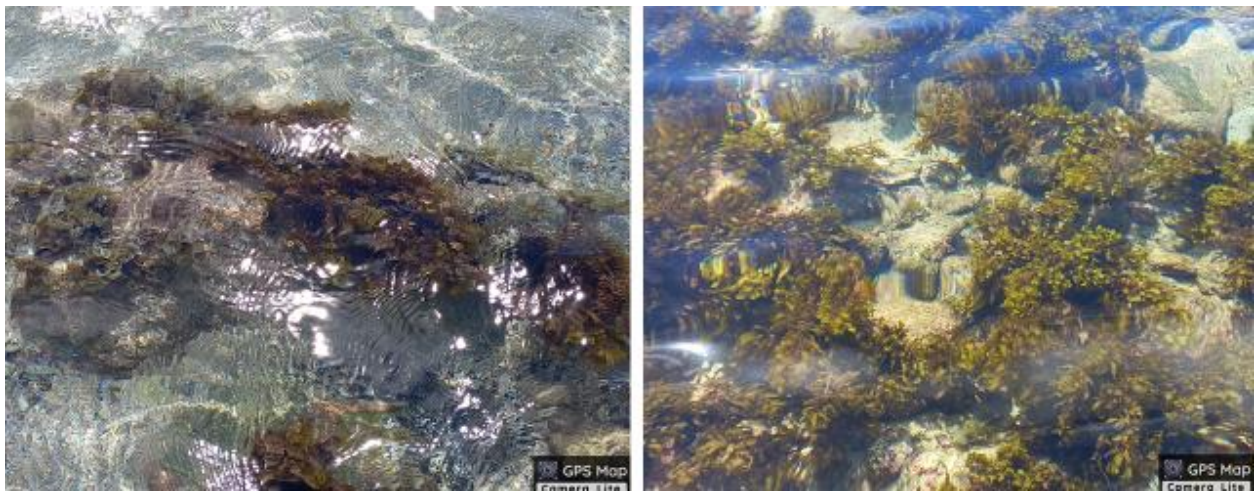
Similar to Site 20, this site is a high energy area with the reef located about 20 meters away from the coastline. There is good flushing and water clarity is very good (90%). Sand makes the dominant substrate with scattered stones and rock boulders. Coral rubbles (25%) were also noted with dead corals covered by algae (25%). Marine algae (*Padina* and *Sargassum*)

Visible sandy substrate with clusters of marine algae

*Sargassum* sp and *Padina pavonica* on coral rubbles and stones

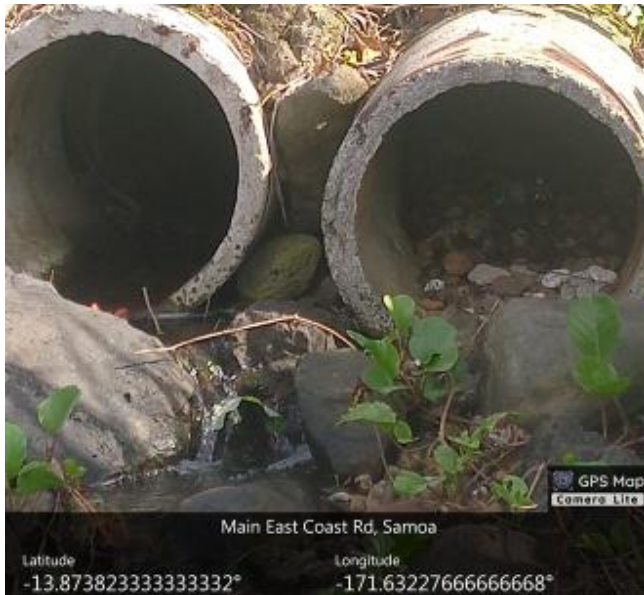
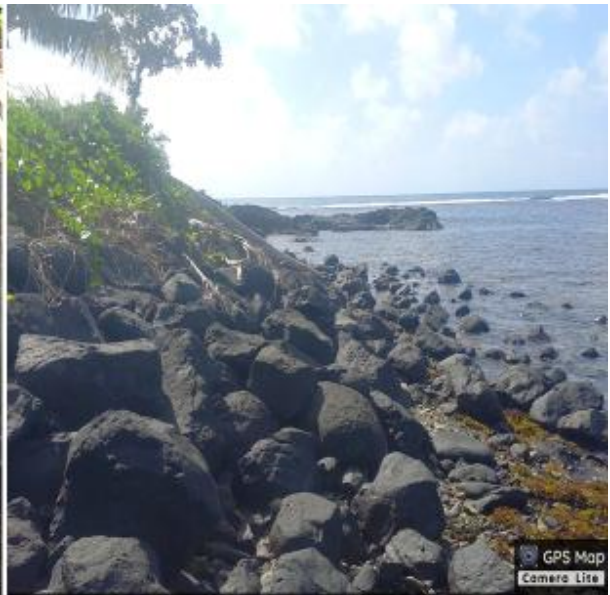
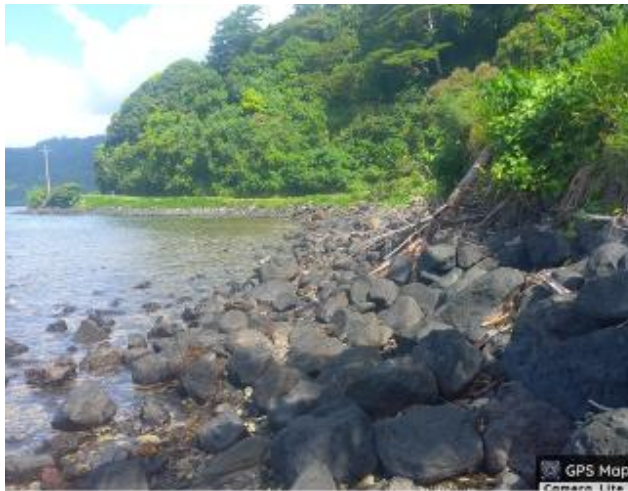
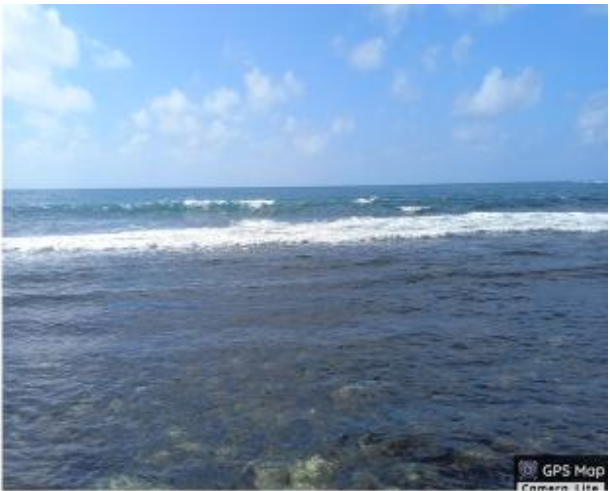
include mostly green fish. No live corals or fish recorded. Noted here are two road drainage culvert pipes that discharge surface water into the sea. The opposite inland side of the road is visible through the pipe as it is clear of debris.

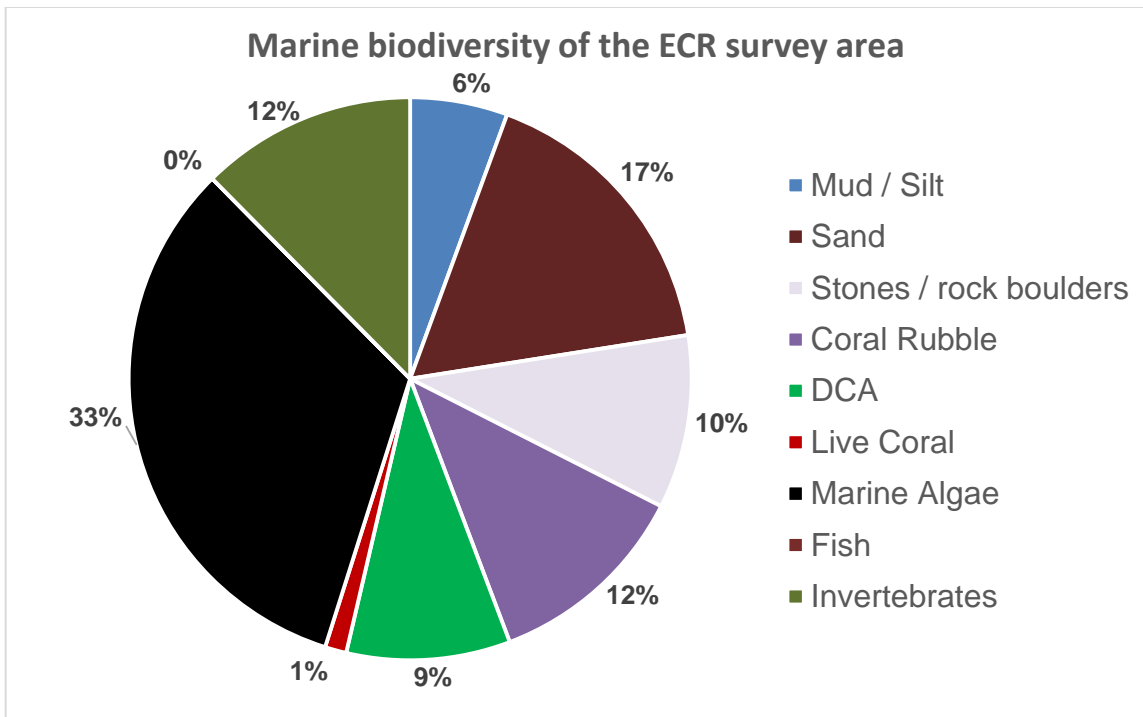
The overall status of marine biodiversity in the proposed project area from Letogo to Saoluafata is summarized below.

Figure 27: Existing marine biodiversity of the ECR survey area
