# East Coast Road – Slope Stabilization Project (ECR-SSP)

## Environmental and Social Impact Assessment (ESIA) Report

(Ver 4; updated 3<sup>rd</sup> December 2024)

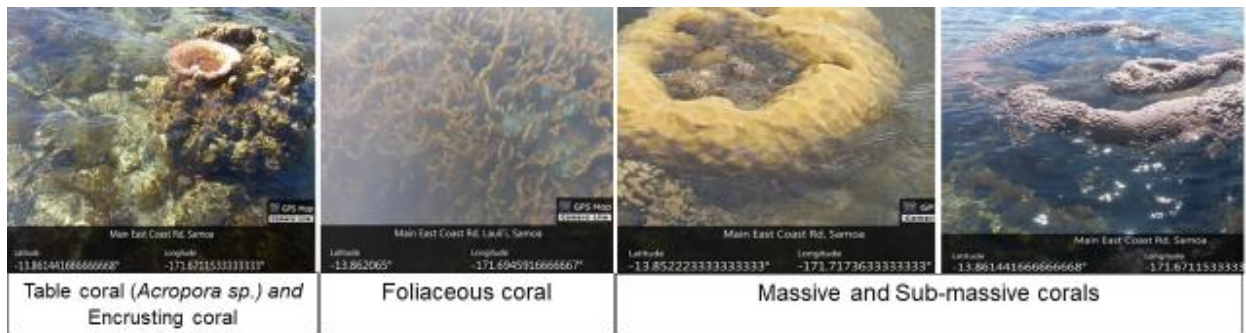
**Plate A: Live coral forms recorded in the ECR survey area**

The area has only 1% live corals, occurring in Sites 14, 15, 16 and 28. Coral cover is very low and only include the table coral and massive and sub-massive coral forms which also indicates low coral diversity. These types are common in high energy areas being more resilient to wave actions. Corals are animals that require certain favorable environmental conditions for good growth. The dominant abiotic factors in the coastal areas in addition to exposure during low tide, high energy and high water turbidity in some sites are unfavourable and suppressive to coral growth. However, this assessment is certain that coral growth, diversity and abundance is much better in the outer reef areas than the coastal areas due to the existing environmental conditions.

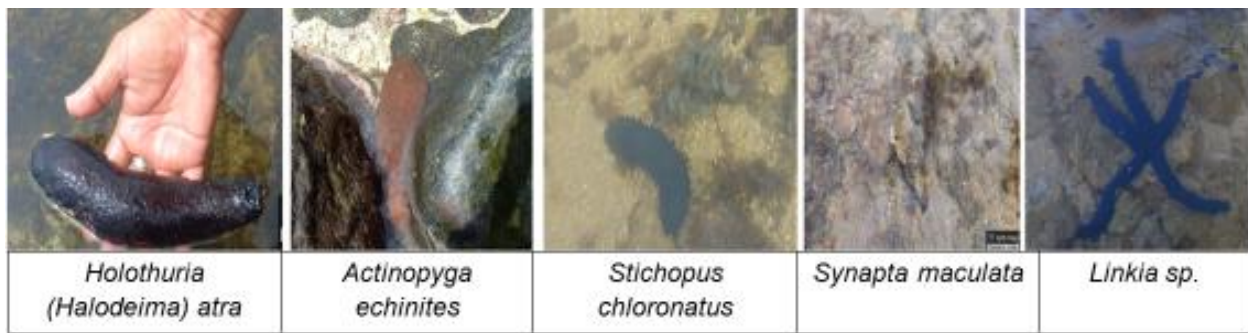
**Plate C: Invertebrate species recorded in the ECR survey area**

Not a single fish was spotted throughout the entire coastal survey area. It might have been due to either the exposure at low tide or the high energy from waves and currents. Invertebrate abundance is 12%, dominated by the Green fish (*Stichopus chloronatus*) followed by Lolly fish (*Holothuria (Halodeima) atra*), Blue starfish (*Linkia sp.*), Peva (*Synapta maculata*) and Surf redfish, *Mama'o (Actinopyga echinites)*.

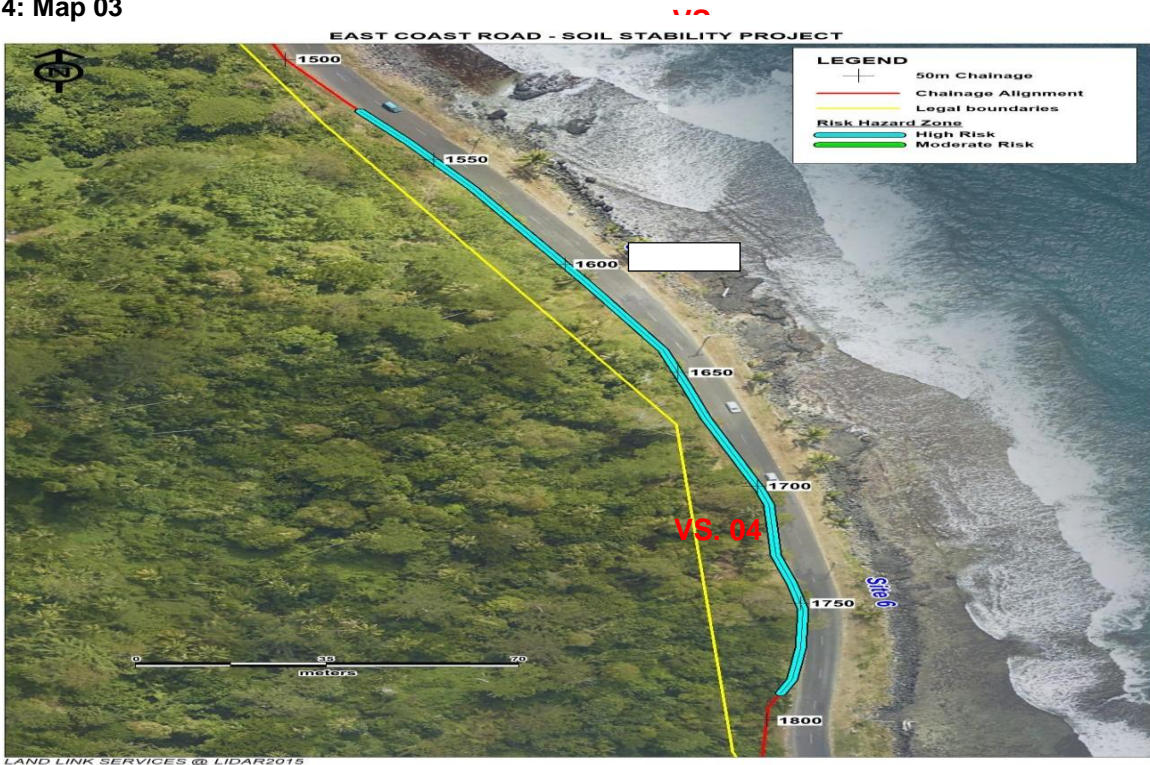
**Site 4: Map 03**

Site 4 is an expansion of the winding road from site 3 towards the west end of Laulii village. Species that are commonly found as canopy trees include *A. chinensis*, *F. moluccana*, *Terminalia catappa*, and few of *S. saman* trees. Unlike in site 3, some species are scarcely found and sometimes absent like the *Garuga floribunda* and other sub canopy trees and shrubs. *A. chinensis*, *F. moluccana* and *Terminalia catappa* shared about 100% of the upper and emergent canopy while *H. tiliaceus* continue to be the dominant tree/shrub (about 80%) of the sub-canopy layer. *C. nucifera* are noticeable along the steep upper road cliff and ridge flat margin presumably an old plantation site belongs to the people and village of Laulii. Dry coconuts and heavy fruits of high canopy trees rolled from the upper slopes such as *Inocarpus fagifer* (ifi) combine with *K. hospita*, *C. odorata*, *Barringtonia asiatica* (futu), *M. harveyana*, *P. garberi*, *C. inophyllum*, *G. ramiflorum*, *M. citrifolia* and *Grewia crenata* to form the sub-canopy structure of this site. There are few vines and ground cover species found in this area compared to the disturbed and open areas at previous sites, this could be an impact of the slope direction (slope facing eastward direction of the bay-like formation of Laulii).

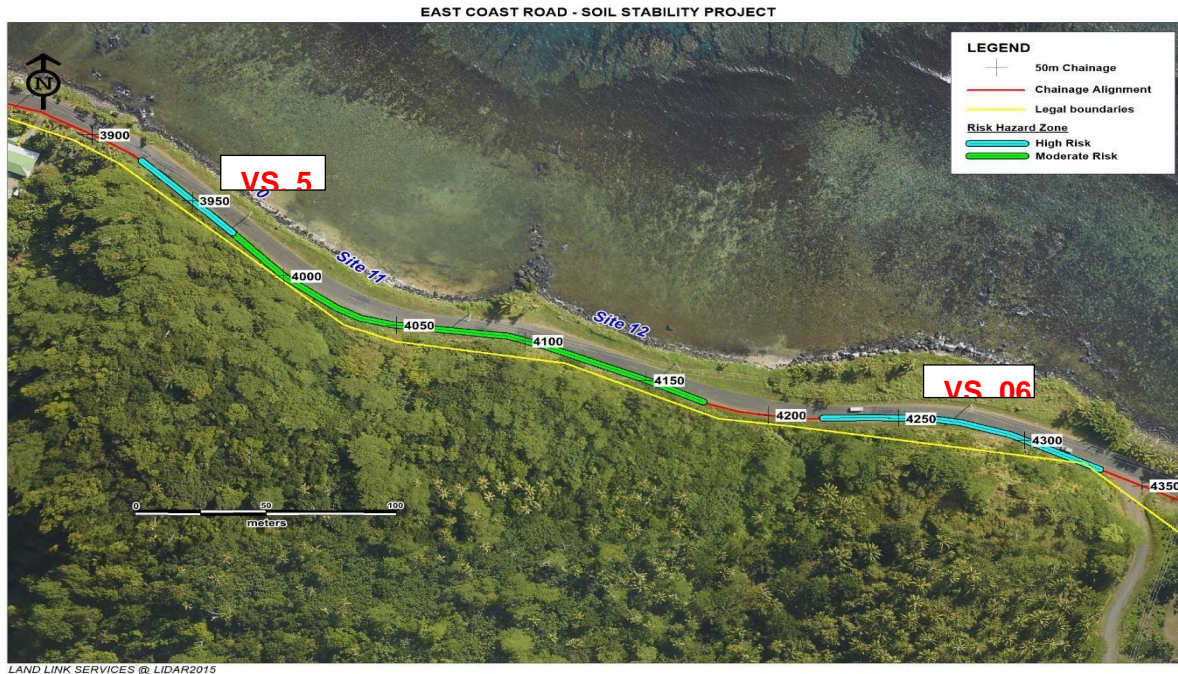
**Site 5 & 6: Map 04**

Site 5 is only about a 50m strip between chainage 3,920 and 3,970 just at the beginning of Leusoalii, a sub village of Lotuanuu. The dominant canopy trees of the site are *Falcataria moluccana* (tamaligipaepae) about 70%, *Intsia bijuga* (ifilele) about 10%, *Dysoxylum samoensis* (maota mamala) about 5%, *Garuga floribunda* (manau) about 3% and *Mangifera indica* (mago) about 12%. The most common sub-canopy trees and shrubs are *H. tiliaceus* about 60%, and another 40% is shared between *A. pavonina*, *C. elastica*, *M. harveyana*, *F. tinctoria*, *A. cochidiensis*, *C. asiatica*, *Adissa eliptica* (togovao), *Flacourtia rukam* (filimoto), *K. hospita* (fuafua), *C. nucifera*, *M. citrifolia* and *Ixora samoensis* (filofiloa). The less common trees found in this community are *C. odorata* (mosooi), *Grewia crenata*, and *Myristica fatua* (atone). The common understory species are clumps of *Zingiber zerumbet* (ava pui/faua povi), *Codyline fruticosa* (ti vao), *Nethrolepis hirstula* (vaotuanui), *Asplenium nidus* (laugapapa), *Faradaya amicorum* (an indigenous woody vine commonly found in lowland to montane forest – mamalupe) and *Microsorium grossum* (lauauta). The other notable plants are *Mikania micrantha*, *Epiprenum pinnatum* (tuafaga/fuelaufao), *Clerodendrum inerme*, *Dioscorea bulbifera*, *Operculina diffusa*, *Ipomea micrantha*, *Ipomea pers carprae*

*H. tiliaceus* (fau) in clumsy stand dominates the sub-canopy layer. Also mixed in with it are *A. pavonina* (lopa), *F. tinctoria* (mati), *C. elastica* (pulumamoe), *M. harveyana* (laupata), *Ficus scabra* (mati mageso), *C. asiatica* (fisoa) and *Pandanus tectorius* (an indigenous screwpine common in littoral areas – fasa).

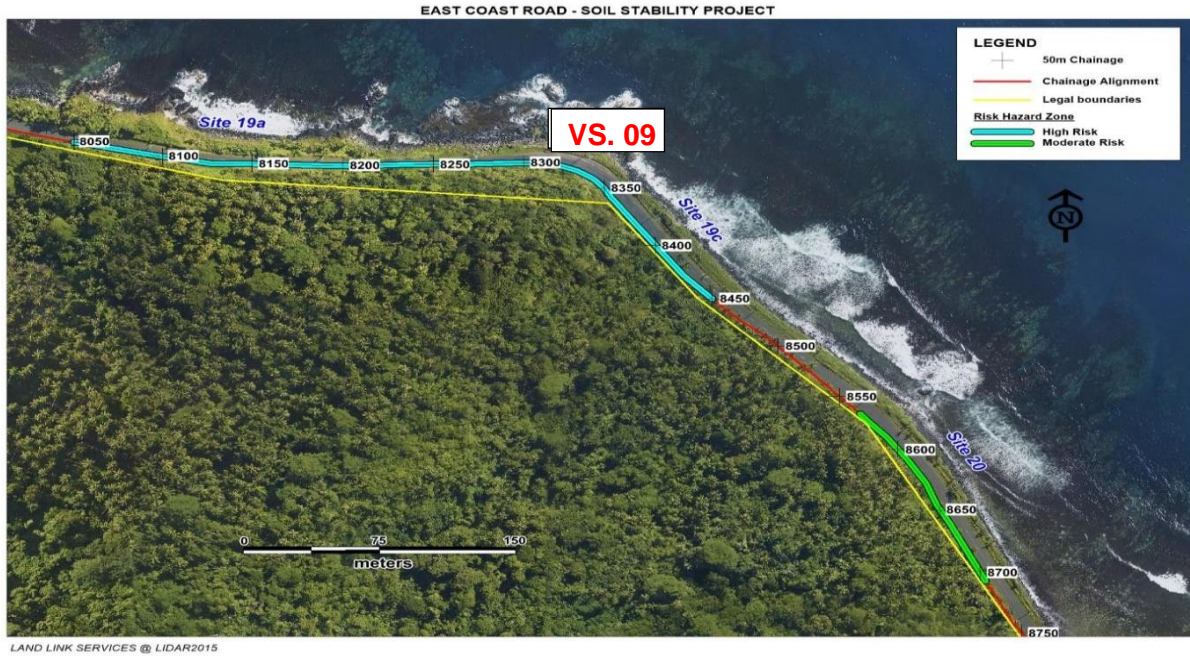
Site 9: Map 07

Site 9 is about a 400m long strip between chainage 8,040 and 8,450 to the east of Lotuanuu village. The upper canopy trees of this site are mostly *Terminalia catappa* about 70% and scattered *F. moluccana* and *Albizia chinensis* combine about 30%. Other important trees that are less common in the upper canopy are *R. taitensis*, *Inocarpus fagifer*, and *Elattostachys apetala*. *H. tiliaceus* is the most common sub-canopy tree about 50% with *A. pavonina* the second dominant about 30% and *M. haveyana* about 20%. The less common sub-canopy trees include *K. hospita*, *Flacourtia rukam*, *Ficus tinctoria*, *Crewia crenata*, *Allophylus timorensis*, *Barringtonia asiatica*, *Neonauclea forsteri*, *Pipturus argenteus*, *Barringtonia samoensis*, *Sterculia fanaiho*, *Cananga odorata*, *Morinda citrifolia*, *Hernandia nymphaefolia*, *Glochidion ramiflorum*, (*masame*), *Fagraea beteroana* (*pualulu*), *Thespesia populnea* (*milo*), *Calophyllum inophyllum* and *Dyospyros samoensis* (*the black ebony tree – auauli*). Agricultural crops like *A. incisus* (*ulu*), *C. nucifera* (*niu*), *Musa sp* (*fai*), *Colocasia esculenta* (*taro*), *Alocasia macrorrhiza* (*taamu*) are also found in small number near the roadside except *C. nucifera* that it scattered throughout the entire site. The understory species are *Dendrolobium umbellatum*, *Colubrina asiatica*, *Arundo sp*, (*fiso*), *Geniostoma rupestre*, *Psidium guajava*, *Adissia elliptica* (*togovao*), *Aidia cochidiensis* (*aso*), *Cyandra samoensis*, *Pandanus tectorius*, *Codyline fruticosa* (*lauti*), *Ficus scabra* (*mati mageso*) where *D. umbellatum* and *C. asiatica* the most commonspecies in this layer. Other species that are common on the ground floor and on top of the sub-canopy layer are vines like *Opeculina ventricosa*, *D. bulbifera*, *M. micrantha*, *Hoya australis*, and *Ipomea pescapre* (*fuemoa*) along the coastline. The ground cover are *Derris malaccensis* (*ava Niukini*) currently forming dense thickets in several areas, *Epipremnum pinnatum*, and two common indigenous ferns *Asplenium nutans* and *Microsorium grossum*.
